Geotechnical problems in Sierra Valle Fertil road crossing

Abstract. National Road 150 passes through the central region of Argentina and is part of a bi-oceanic corridor from Brazil to Chile. In Sierra de Valle Fertil it has traversed sedimentary rock formations where they have built five bridges and six tunnels. During construction, instabilities phenomena were seen in both tunnels and surface works. In tunnels different behaviors were observed on hard rock and soft rock. Slope instability processes include mass displacement and failures due to decompression generated by excavation. Some reported cases occurred during the execution of the work, including various types of failures. In many sectors, rock masses showed a high degree of weathering. Analyses for the design and mitigation actions undertaken are described. Details emerged in the foundation of the bridges that make the section also arise.

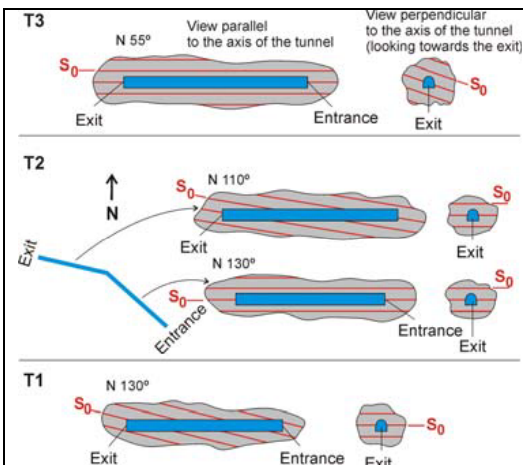
Tunnels T1, T2 and T3 were excavated in a sequence of fine silty and tuffaceous sandstones with interbedded siltstones and triassic dark shales. They have similar structural geology features, but as the tunnel alignments changed, their influences were different (figure 3) [4].

Figure 3. Influence of geological features on T1, T2 and T3

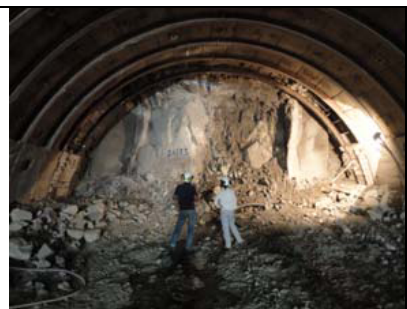
Figure 4. Cataclastic fill between rock blocks in T3

The main fault areas have been mapped in outside outcrops, with strike sub-parallel to the valley and T3 axis, and perpendicular to the direction of movement of the slide. This morphology was generated by the relaxation of the valley sides during the formation of the hill and the erosion of the antecedent river that carved it (figure 4).

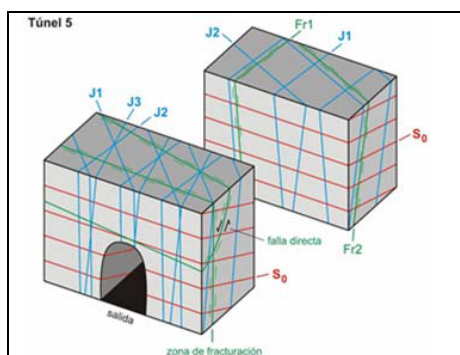
Tunnels T4 and T5 shared the same geology and structural features (figure 5). In this case, they are formed by red cross-stratified sandstone (Fm. Talampaya), with red clay levels and layers and lenses of coarse matrix. Tunnel T7 was in grey greywakes, formed in Carboniferous age. They have well stratified planar layers of variable thickness (from 0.5 to 0.10 m to 1 m). There are thin layers of white sandstone lens shaped, of centimeter thickness, interspersed in the gray greywacke.

Figure 5. Structural features of T4 and T5

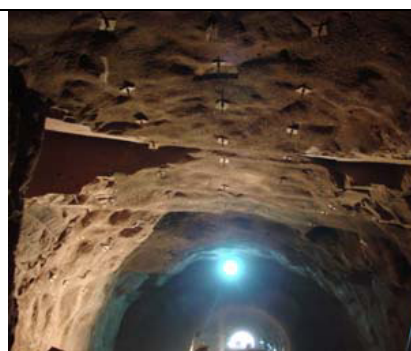
The main problem encountered during excavation was the falling wedge blocks of rock formed by the combination of discontinuities. These falls caused some overbreaks mainly in the crown and shoulder (figure 6).

Figure 6. Typical rock wedges formed in T5

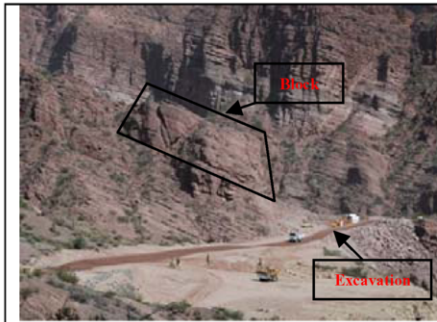
The example is in Sta. 30 + 800. There are a group of blocks having approximately 13 m high, 22 m wide at the front, parallel to the axis of the road and 43 meters long.

These blocks are of red sandstone on whit a unit weight of 2.4 t/m^3 and a total weigh of about 28240 tons. They rest on a bedding plane with dip 20 to 25° at 36° towards the sector of road (figure 7). There is no interstitial water in the ground.

Figure 7. Block with Planar discontinuity

As a result of the analysis, it was decided to reshape part of this unstable mass.

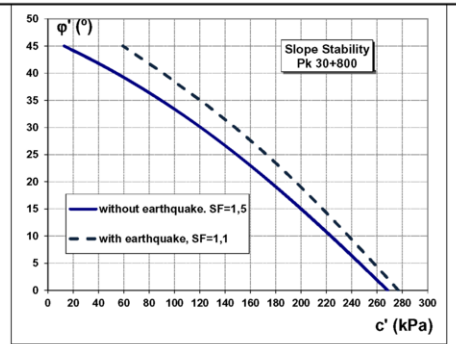
Based on these conditions, pairs of values of cohesion (c) and friction (ϕ) for which safety factors required were evaluated. In sum, the ratios obtained set a "limit" of combinations of strength parameters, for which the conditions which required stability is achieved (Figure 8).

Figure 8. Combination of strength parameters necessary to achieve safety factors set

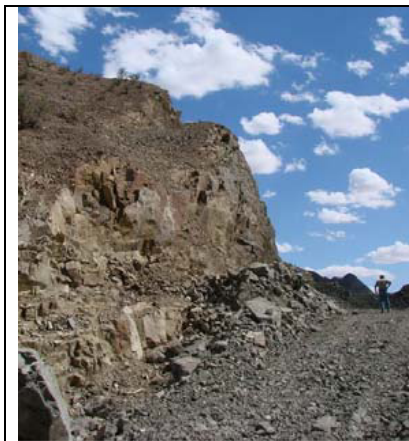
One example was located in Sta. 34+200. There is a case of breakage by rotation of the upper part of columns of rock formed by two discontinuities sets (Figure 9).

Figure 9. Block fall due to toppling

The arrangement of family joints in the sector showing the presence of a sandstone formation with dip slightly vertical, arranged towards the slope.

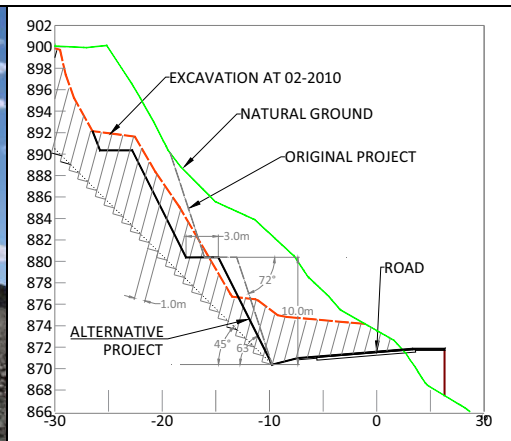
Figure 10. Redesign of slope

In order mitigate the problem, a new slope was redesigned and verified. It involves consideration of the average slope, including berms. This average slope equals 1H: 2V, i.e. an angle of 63° to the horizontal with berms 3 meters wide each and 10 meter high. (figure 10). The earthquake acceleration values used were: $a_v = 0.05g$; $a_h = 0.25g$.

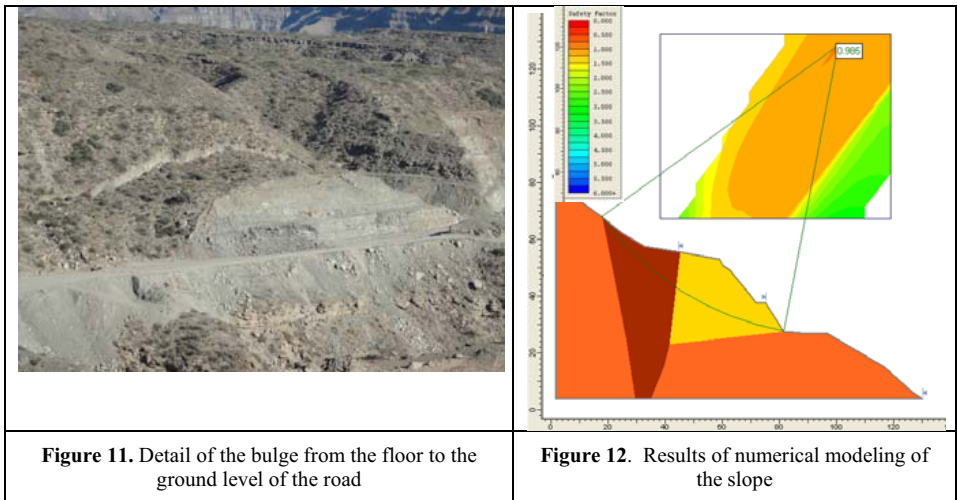
A very good example was developed in Sta 22 + 090 to 22 + 380, where there was a significant incident, with massive failure and invasion of the road trace. Subsequently, it was observed that the monoliths measurement showed no signs of movement.

To check the security status of the slope in the pre-sliding conditions, a numerical model of the slope was performed to simulate the observed slip (figure 11). Having verified the failure, a back-analysis with a factor of safety of 1, was performed to determine the average properties to justify the observed slip (figure 12).

Figure 11. Detail of the bulge from the floor to the ground level of the road

Figure 12. Results of numerical modeling of the slope

As a solution, the trace was relocated, the slid mass was lightened and channel runoff pathways were constructed.

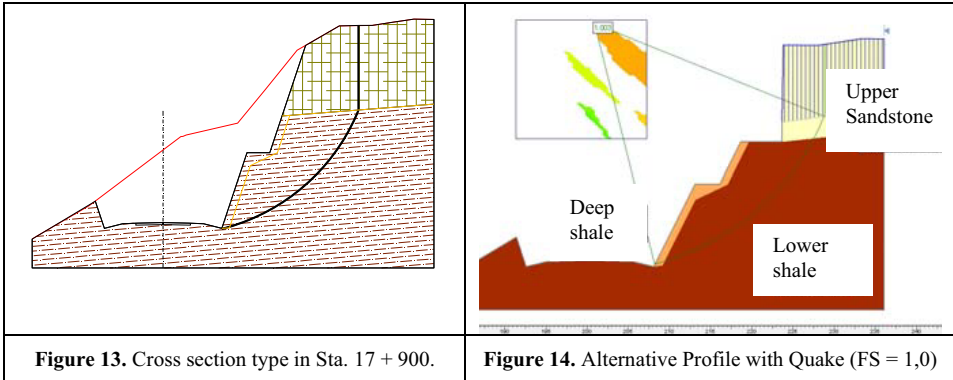
The characteristics of the interbedded sedimentary formations with rigid over weak rock layers produces unstable situations. This case corresponds to the slope at Sta. 17 + 900 (Figure 13).

Lower shales have a tendency to accelerated weathering on its surface that begins after the excavation. Over time, due to daily thermal daily oscillations, or wind action, rocks mass are drying and undergoes contraction and expansion processes. Consequently it is fragmented and loses its cohesive components.

After the excavation, there is side deconfinement in sandstone formation that tends to open discontinuities in the vertical direction, and lower the strength in overall stability. When the vertical crack is formed, upper sandstone acts as an overload to the lower shale. Figure 14 shows the safety factor in limit equilibrium condition obtained for earthquake scenarios.

Such problems warrant the reshape of the cuts and where possible, the use of shotcrete to prevent erosion.

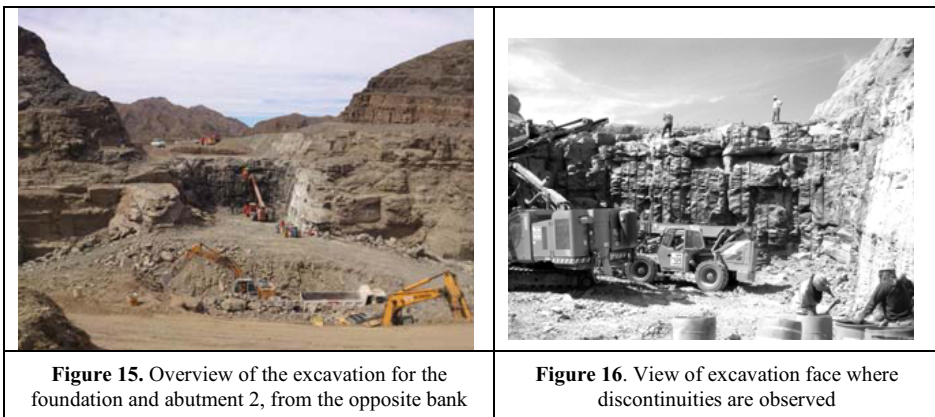
The example described corresponds to one of the abutment of arch bridge 5, that requires small levels of deformations. The abutment is founded on competent fine sandstones. However, subhorizontal stratification produces marked discontinuities (Figure 15 and 16).

It can be seen that the major joints are continuous along the excavation and consequently extend below the plane of the foundation level (Figure 16).

The sum of the openings of the discontinuities in the excavation front was in the order of 40 mm. From a static point of view, it is unlikely to be closed when requested externally bridge structures. In case of an earthquake, the breakage of the asperities that limit the discontinuities, can resulting in settlements, whose limit is given by the sum of the openings.

To avoid settlements in case of an earthquake, a deep foundation was chosen, with transmission of loads below discontinuities, using piles made of 4 inch hollow pipes like those employed in the umbrella tunnel portals.
