International Congress of Science and Technology of Metallurgy and Materials, SAM -  
CONAMET 2013

## Scientific Method applied to Failure Analysis on Engineering Components

Shank adapters or start bars are slim parts of hardened steel used in rock drilling hammers for the mining industry. This extreme type of work occasionally generates premature failures to the bar because of the heavy-duty working conditions.

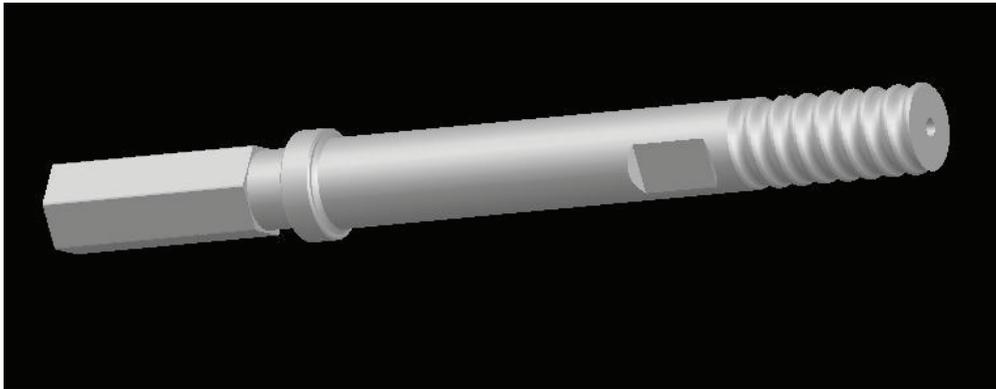
Figure 1 shows the shank adapter design, the object of study. The hexagonal end couples with the pneumatic hammer, and an extension added in threaded part, where the drill bit is mounted.

Figure1. Start bar or shank adapter diagram.

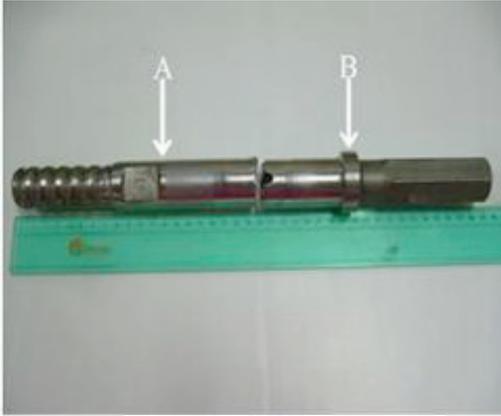
The analyzed shank adapter was received in two parts (A and B), as shown in Figures 2 and 3.

Figure 2. Broken shank adapter.

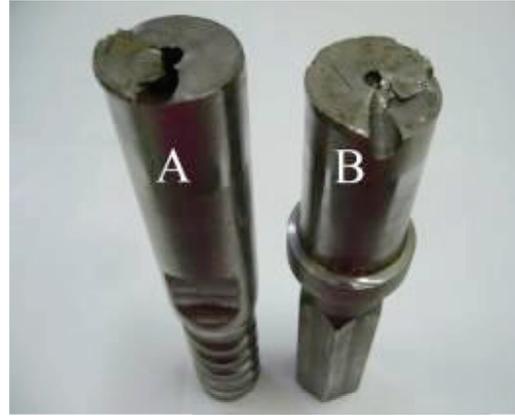
Figure 3. Fracture area.

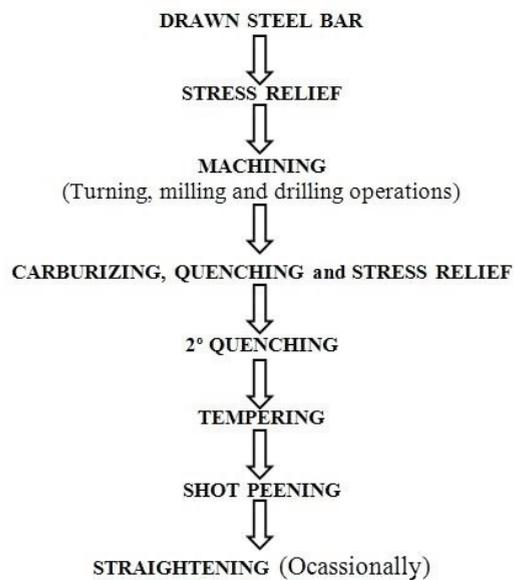
The information collected about the piece manufacturing process is present on Figure 4.

Figure 4. Shank Adapter Manufacturing Process.

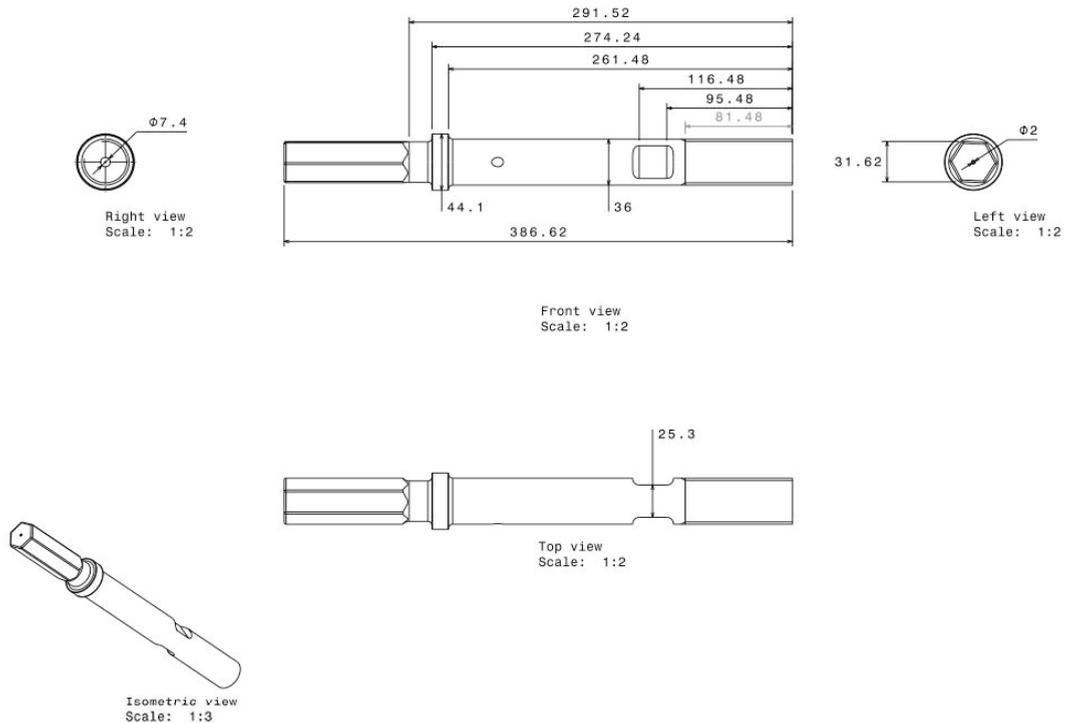
Dimensions and simplified model are shown in Figure 5 and 6. In its design, the shank adapter has a centered hole along the piece's axis and a transversal perforation connected with the centered hole. These perforations are used to let water inside and have the function of removing the shredded material around the bar. The fracture is produced in the intersection of these two perforations.

Figure 5. Shank Adapter Diagram.

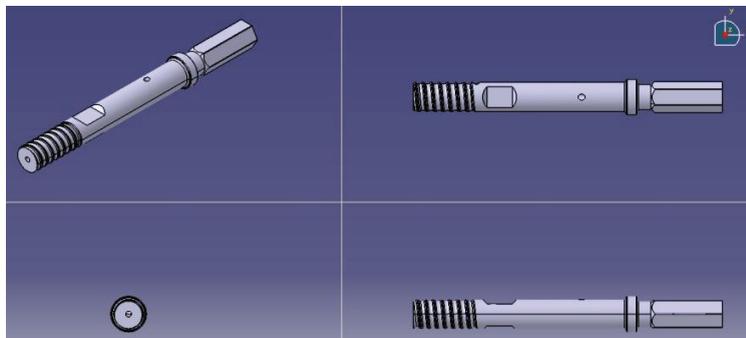
The tridimensional modeling design was based on a technical drawing with the dimensions of the object of study. The corresponding material found in the program database was applied. Then, it was collected the operating data - including regular operating movement types, speeds and pressures, so the loads to be applied to the model could be deduced. An analysis was made using the finite elements method on the loads and restrictions of mobility of anchorages of the parts in their working environment in real life. This determines specific clamping types of the part based on the computer model and determines tensile strengths generated in the whole part produced by loading and clamping. This way, the most concentrated stress areas were found. These areas have the highest chances of material plasticization due to effort magnitude, where material brittleness and later failure occurs.

Fig.6. Shank Adapter Simplified Model

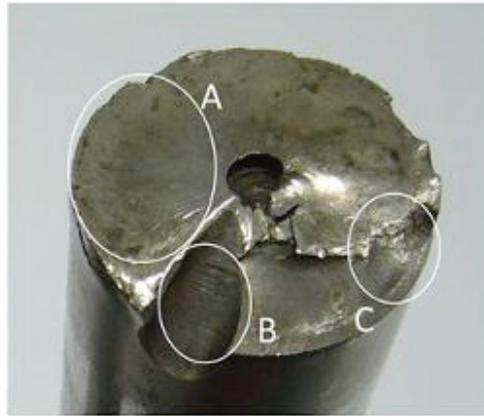
The fracture propagated following two successive processes; those influence regions are signaled in Figure 7. A) origin of stress fracture, B) stress concentration effect produced by the perforation roughness C) brittle fracture with quick propagation.

Figure 7. Fracture Surface Area.

After heat treating, the hardened is generated inside the holes. This high hardness layer with low ductility increases material brittleness. Stress concentration induced by the geometry of the piece, particularly in the holes intersection, added to the high roughness in the hole surface induced the generation of microcracks during the straightening process of the piece. This small internal defects origin an evolving crack due to the cyclic stress applied in the use of the piece producing a typical failure fatigue propagation mode.

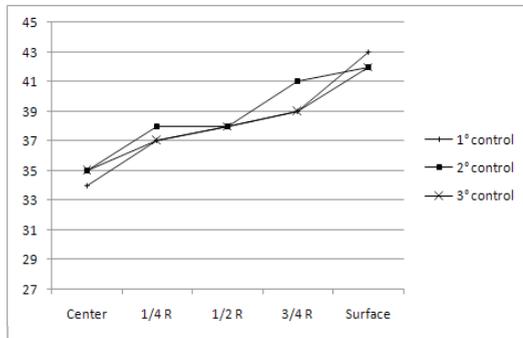
Figure 11. Microhardness profile in hole of the fracture area.

It can be observed in Figures 13 and 14 that although hardness is reduced towards the center, the core hardness is higher relative to the expected value in this kind of steel.

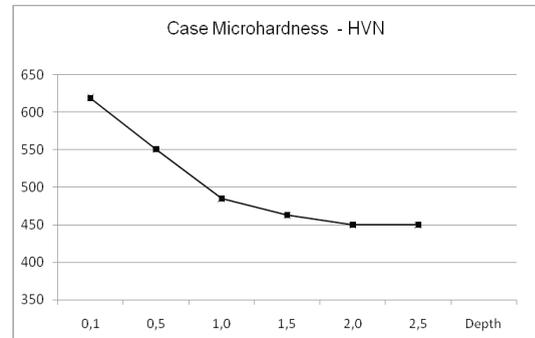
Figure 12. Microhardness profile in outer diameter.

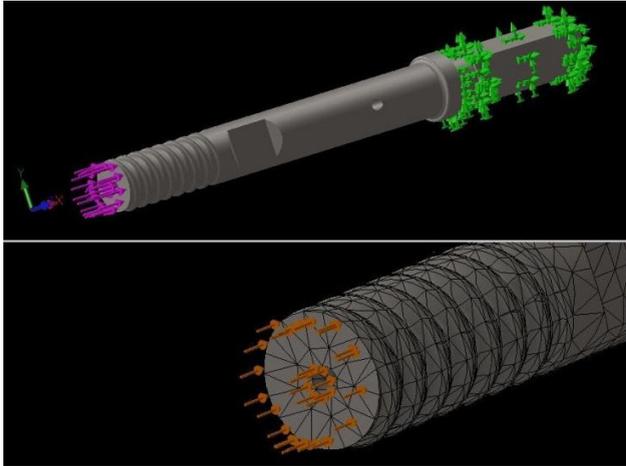
The figures 13 and 14 show the boundary conditions of the loads and fixtures of the simulation model.

Figure 13. Loads.

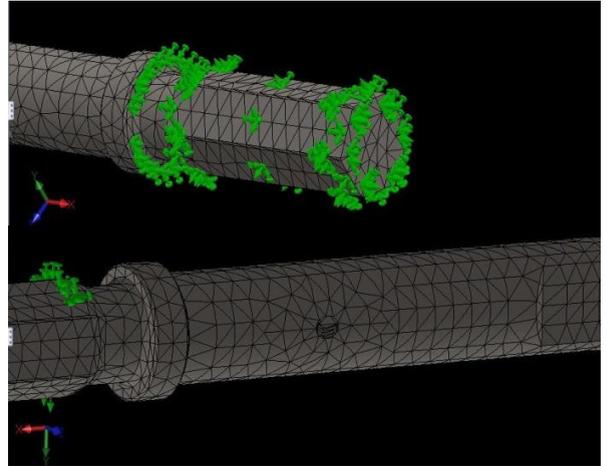
Figure 14. Clamping and Meshing.

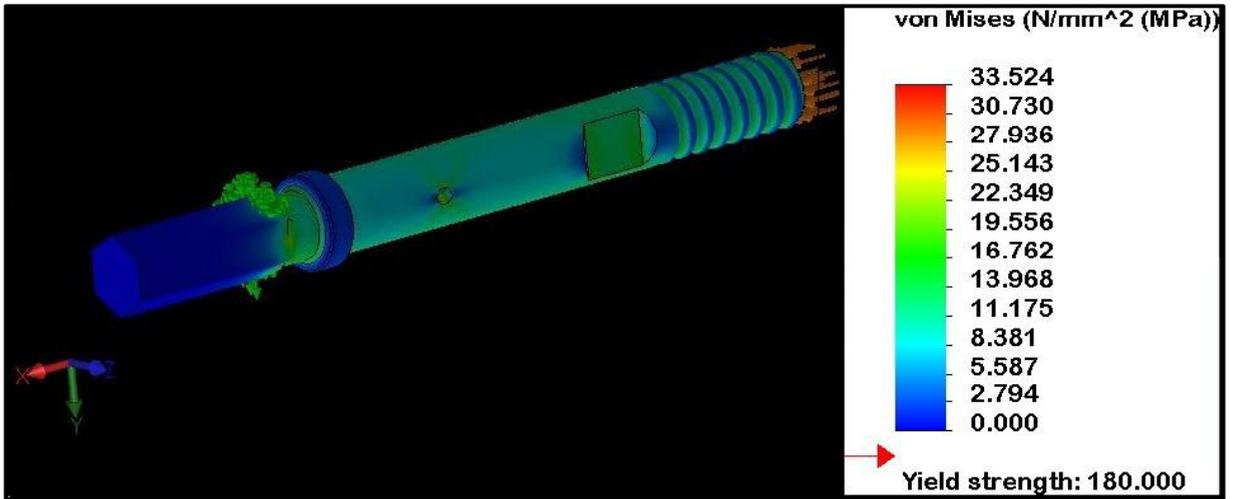
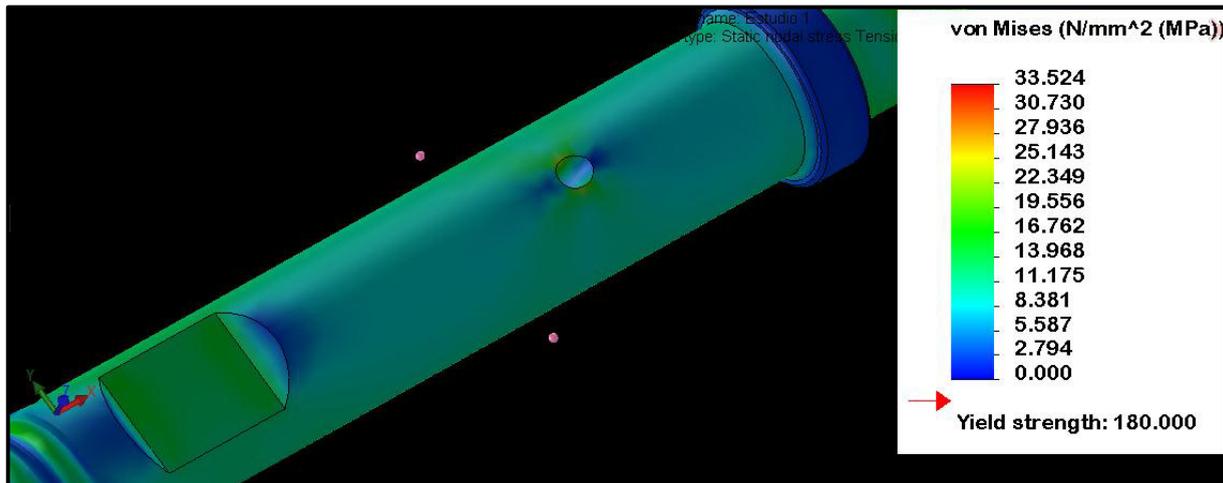
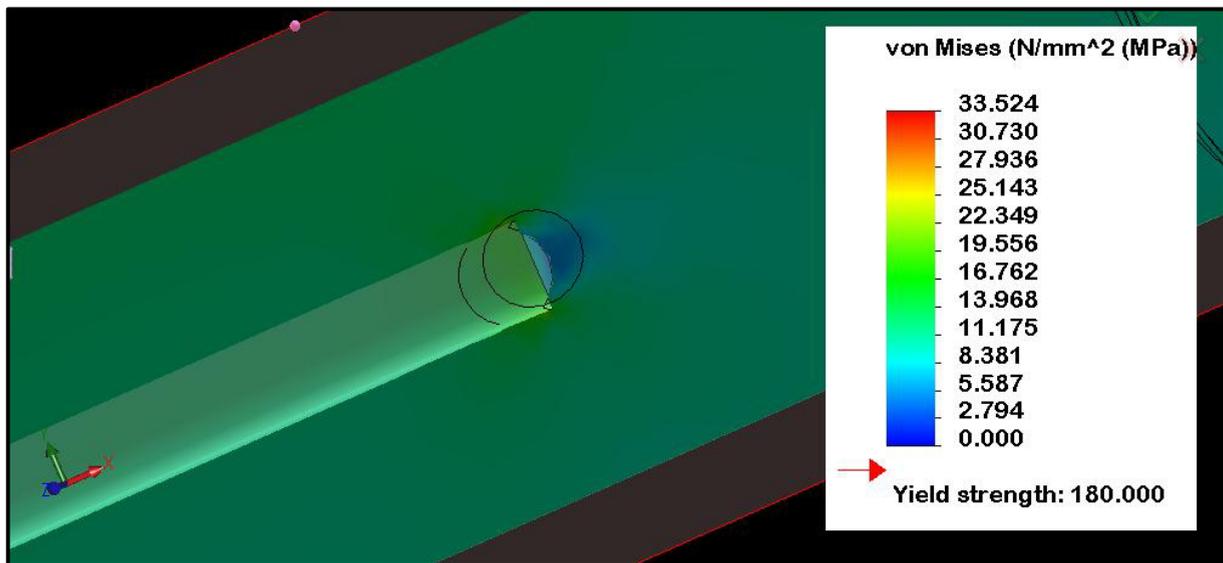
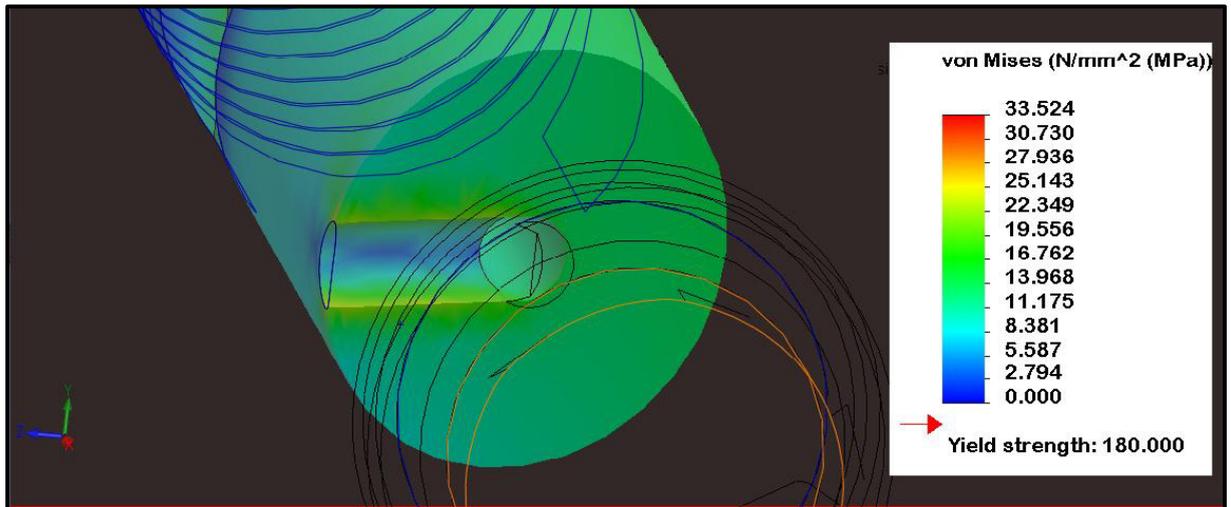
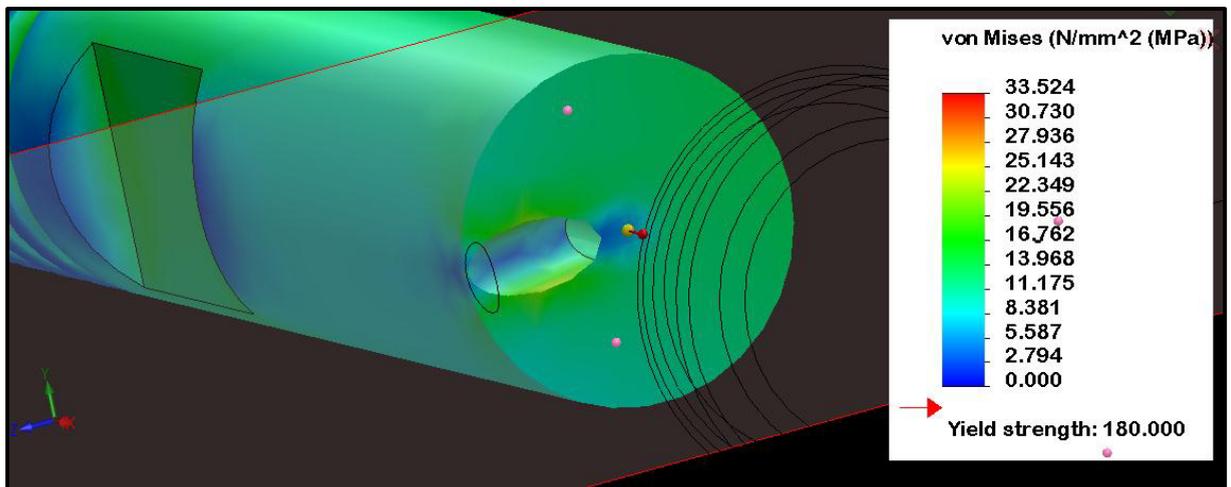
Figure 15. Effort Simulation Results

Figure 16. Von Mises Yield Criterion Maximum Concentration

Figure 17. Longitudinal Section of the Mid Plane

Figure 18. View of the intersection of the lengthwise and diagonal holes.

Figure 19. Cross Section at 60mm of Mid Plane, Perforation Intersection. (Stress Concentration)

In Figures 15 to 19, it is observed the piece that works with flexocompression. Stress concentration occurs in perforation because the area is smaller in this section, and the load is constant, tensile force increases in this place of the shank adapter.

**Part Design:** In technical drawings and because of the loading and clamping, it can be appreciated a stress concentration in the area around the intersection of the two perforations of the part (between the axial or longitudinal and the radial or diagonal). Through effort simulation with FEM, it can be seen that the assumption is correct because the ultimate tensile forces present in the piece are symmetrically located on both sides of the union section between the two perforations. It is evident that this sector of the piece that has the most probability of plasticization and following material cracking.

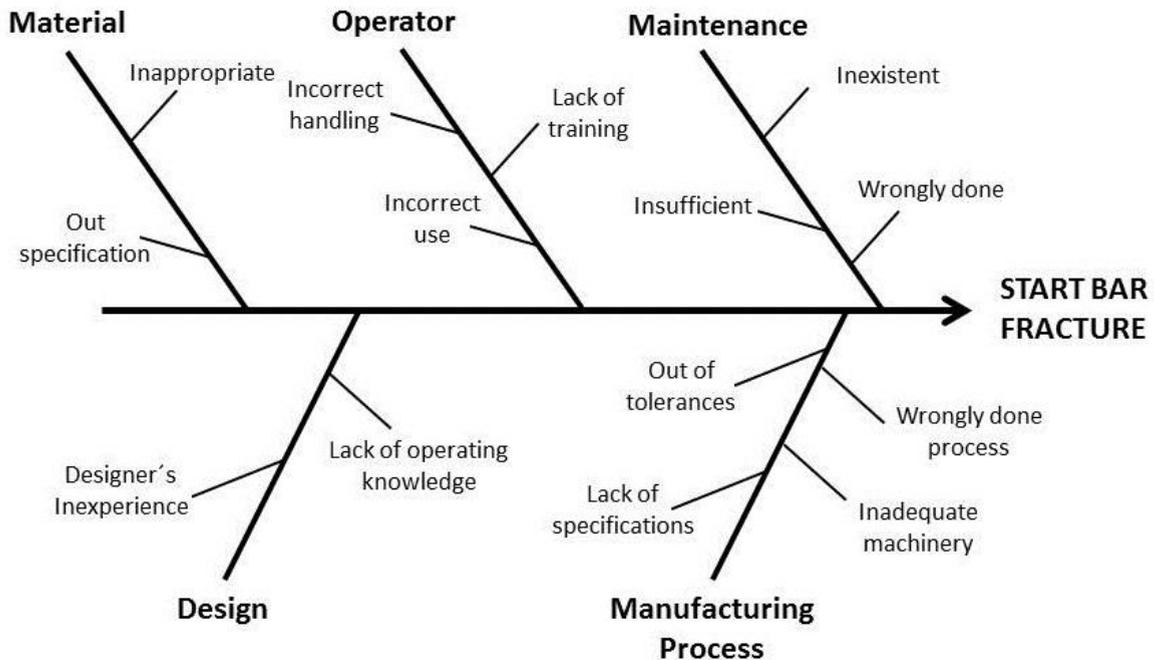
It has been thoroughly analyzed the manufacturing method of the shank adapter taking into account the 5M method. In Figure 20, it can be seen the Ishikawa Diagram.

Figure 20. Ishikawa Diagram.

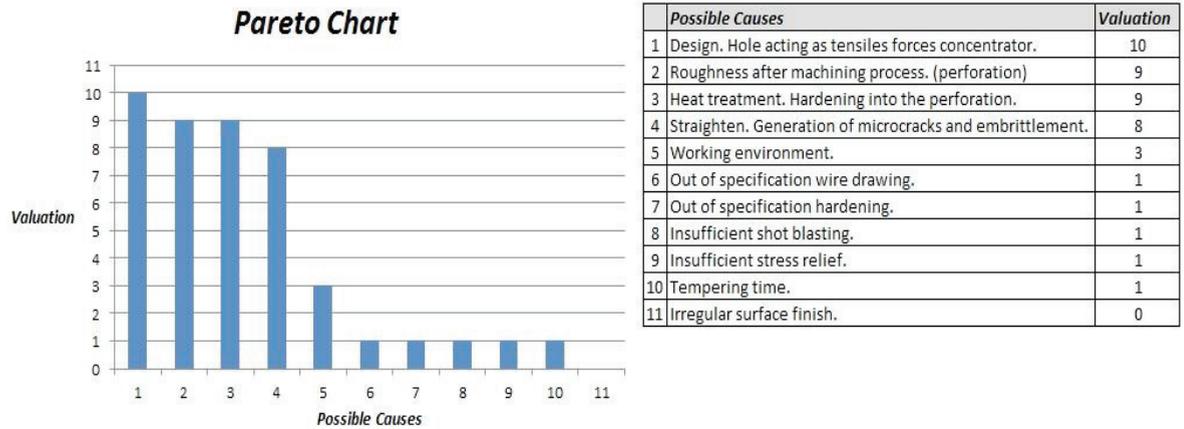
After analyzing this case, it is concluded that there are possible causes more relevant than others, so a Pareto Chart was created (Figure 21) where it is reflected the valuation of the possible causes of the shank adapter failure.

Figure 21. Pareto Chart.

After making the Pareto Chart, it is found that the failure of the shank adapter is related to the combination the most of one causes, to a greater or lesser degree, the main causes are:

- Deficient design. Perforations have a stress concentration effect.
- Roughness after the machining hole process. (Drilling).
- Hardening into the hole.
- Straightening after the hardening. (Appearance of micro-cracks)
